DEFINITE PROJECT REPORT/ ENVIRONMENTAL ASSESSMENT (SP-23)

AMBROUGH SLOUGH HABITAT REHABILITATION AND ENHANCEMENT PROJECT

Pool 10
Upper Mississippi River
Crawford County, Wisconsin

December 2000

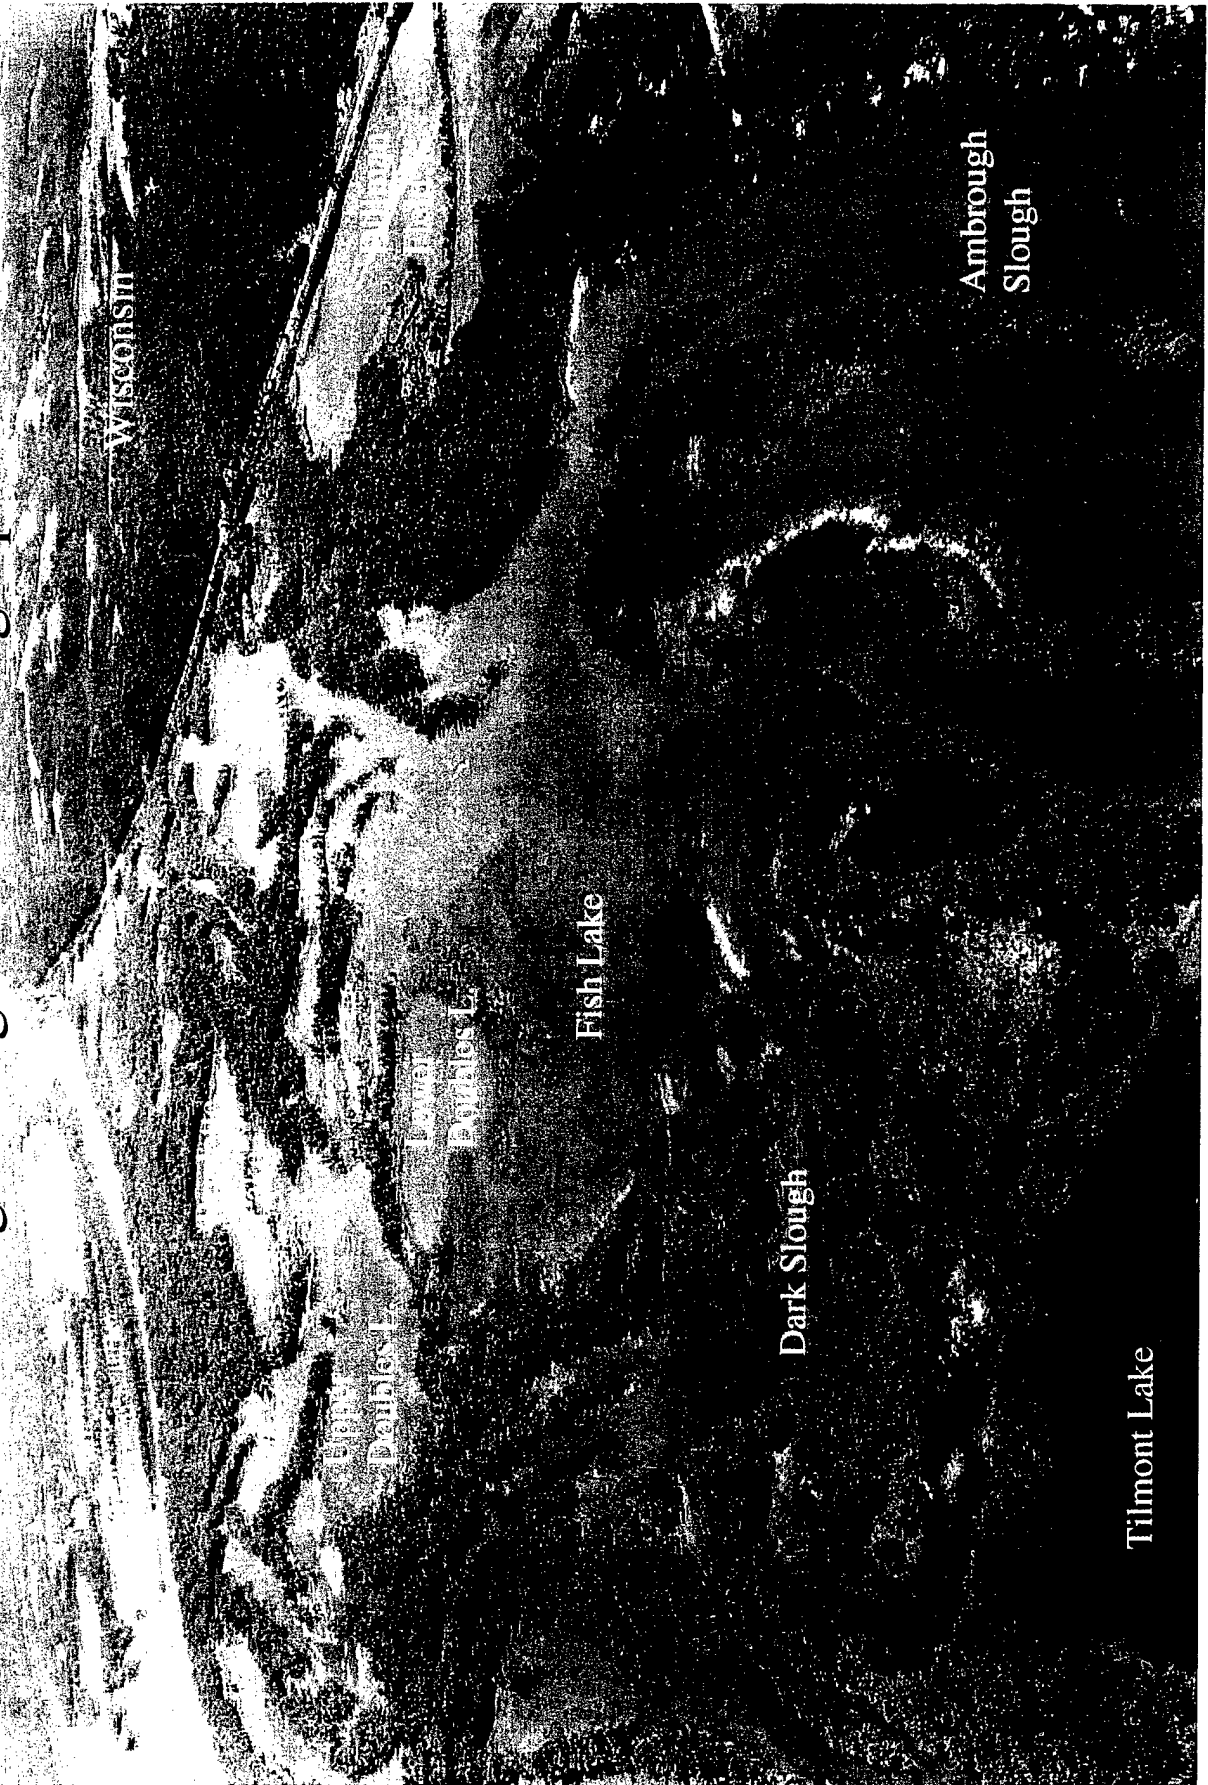
Ambrough Slough Area Looking Upstream

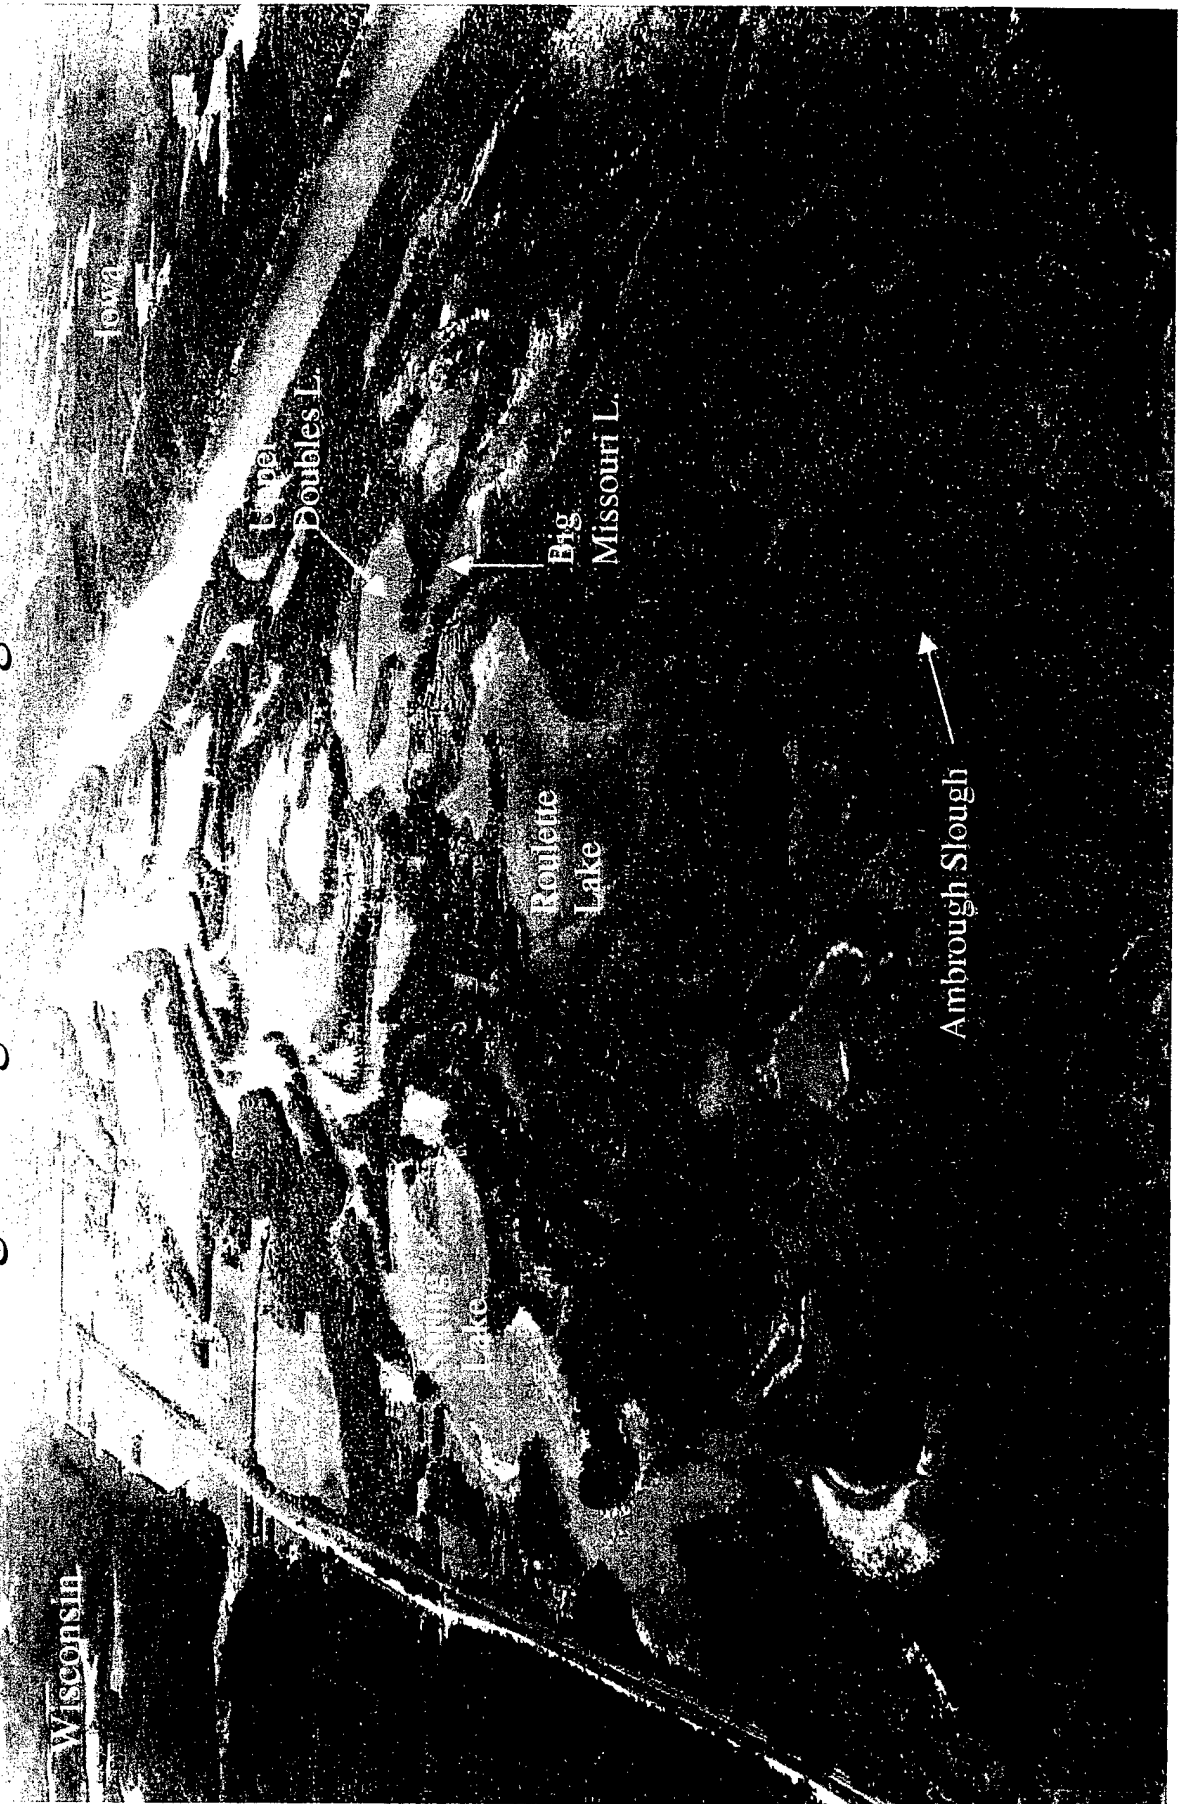
Ambrough Slough Area Looking Downstream
